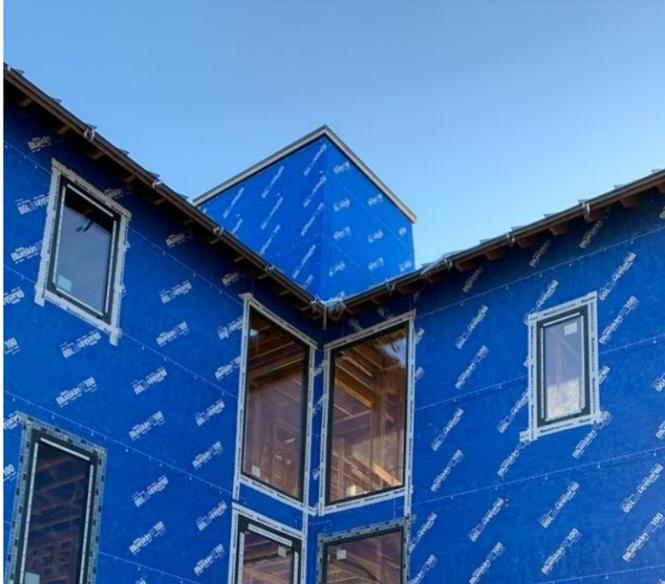
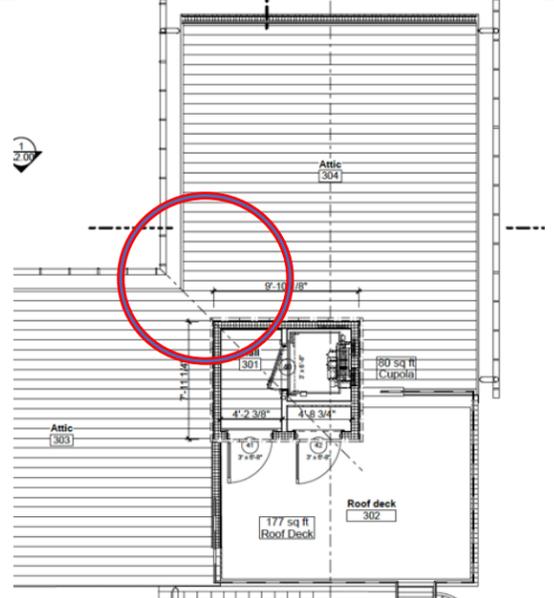
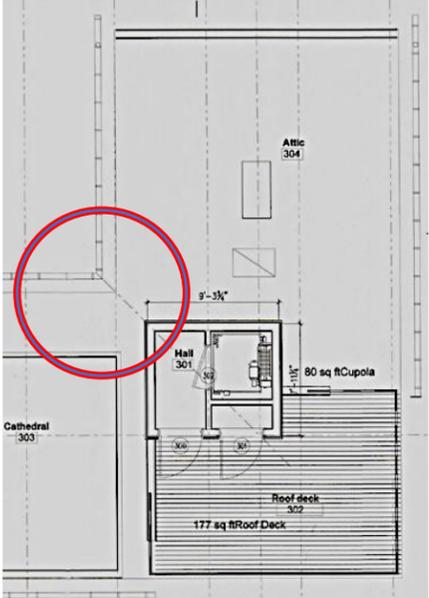
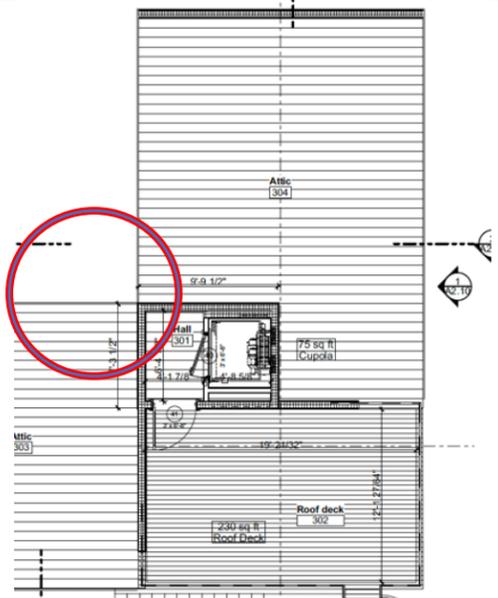
Site Photo 12/20/2019	Approved ZBA #7629 Plans	Plans submitted by applicant for Revoked Zoning Permit # 42345	Denied ZBA #7592 Plans
<p><b>Location of Elevator Shaft</b></p> <p>The elevator shaft has been constructed in the same location as the denied ZBA #7592 plans.</p> <p>This is not in the location that was approved by ZBA #7627.</p> <p>Plans submitted for the Revoked Zoning Permit #42345 also do not show the elevator shaft in this location.</p> <p>Since the elevator shaft has been pulled forward, it is likely that the roof top deck is larger than approved, as seen in the denied ZBA #7592 plan.</p>

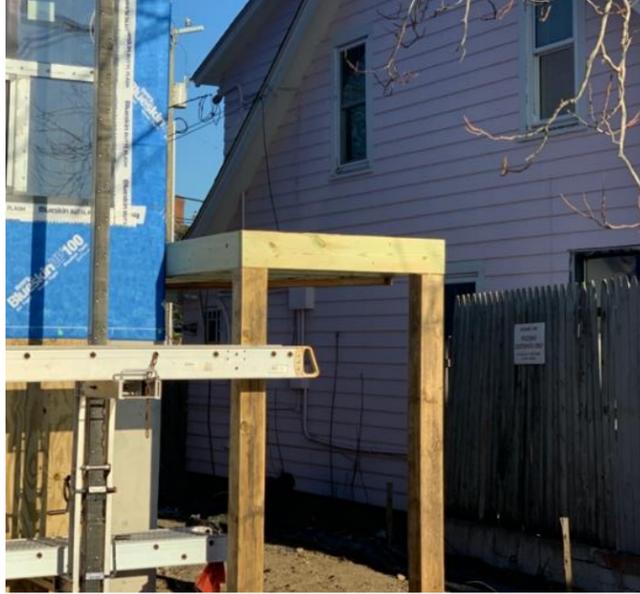
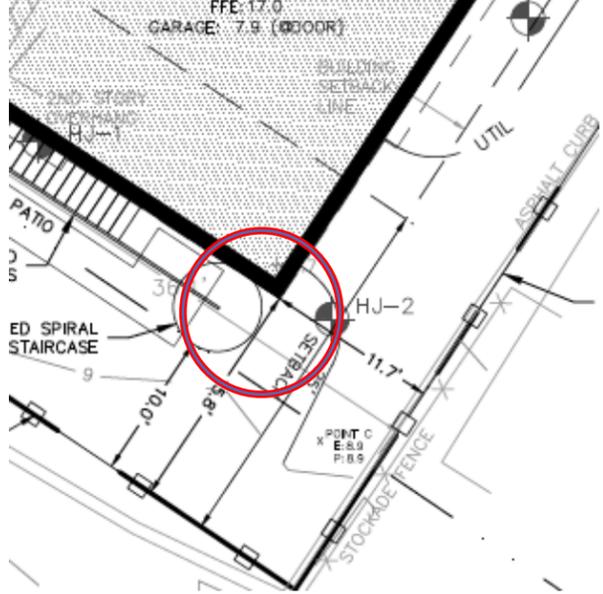
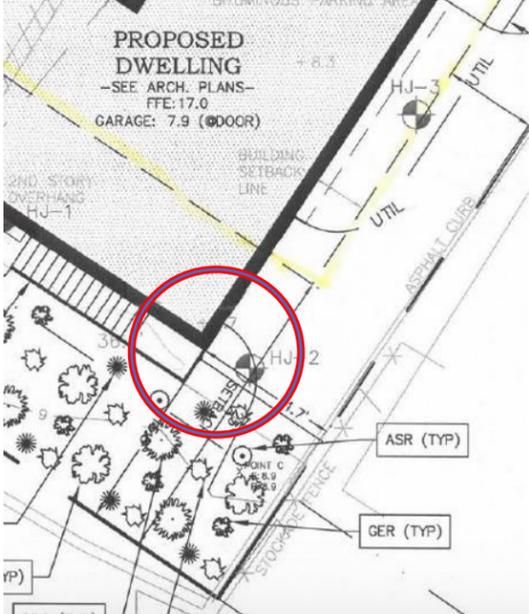
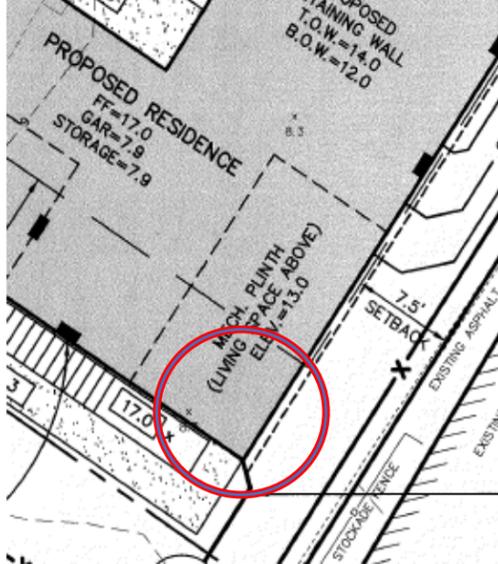
<p><b>New Side Entry</b></p> <p>A side entry has been constructed that is inconsistent with ZBA #7627 approval.</p> <p>Plans submitted for the Revoked Zoning Permit #42345 do not show this landing either.</p> <p>The spiral staircase that was approved per ZBA #7627 is no longer present in the field or on the plans submitted for the Revoked Zoning Permit.</p>

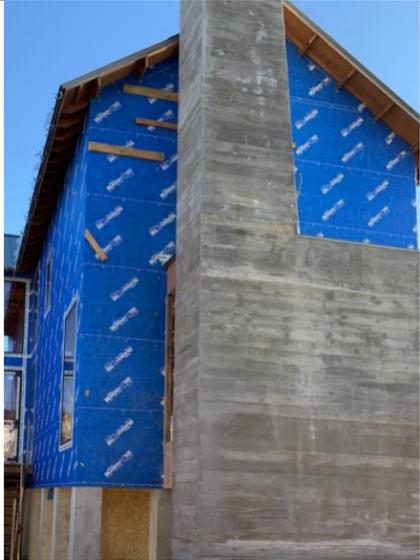
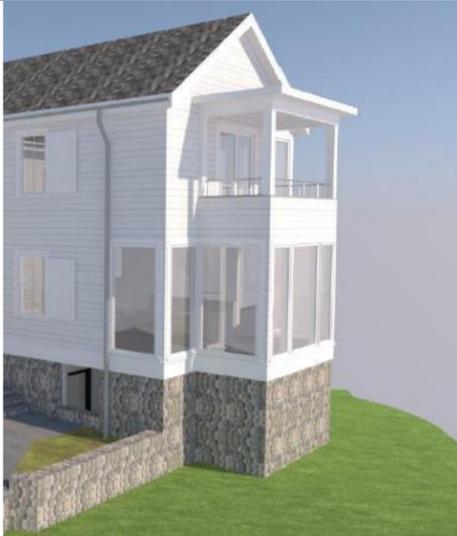
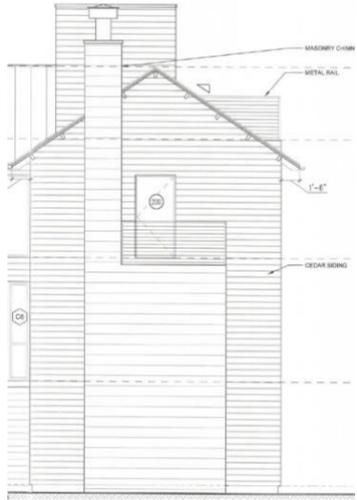
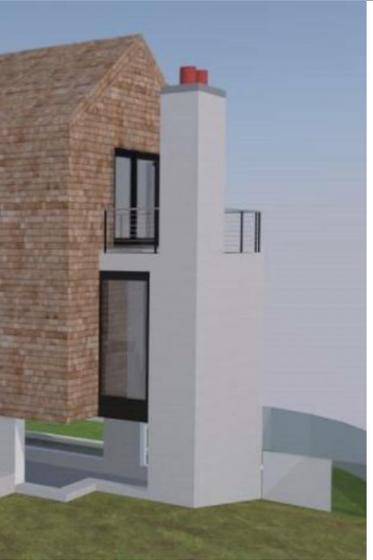
Site Photo 12/20/2019	Approved ZBA #7629 Plans	Plans submitted by applicant for Revoked Zoning Permit # 42345	Denied ZBA #7592 Plans
<p><b>Chimney</b></p> <p>A chimney has been constructed is inconsistent with ZBA #7627 approval, adding a lot of bulk to the building. Instead, the approved plans show a two-story porch.</p> <p>Plans submitted for the Revoked Zoning Permit #42345 show a chimney, as do the denied ZBA #7592 plans.</p>

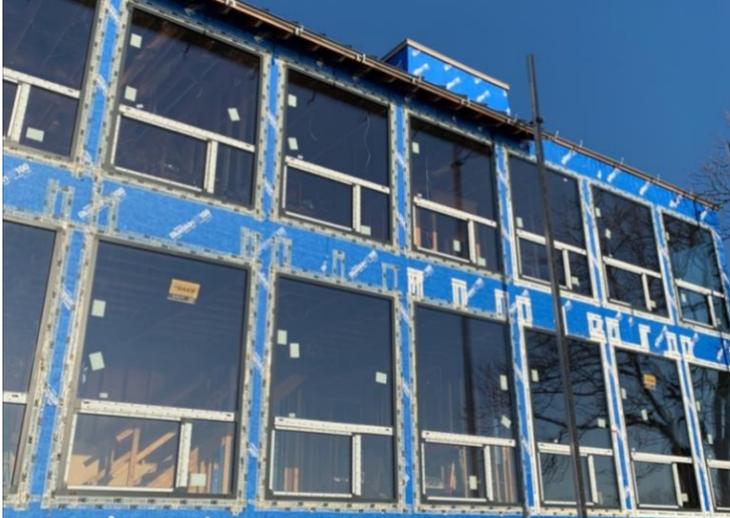
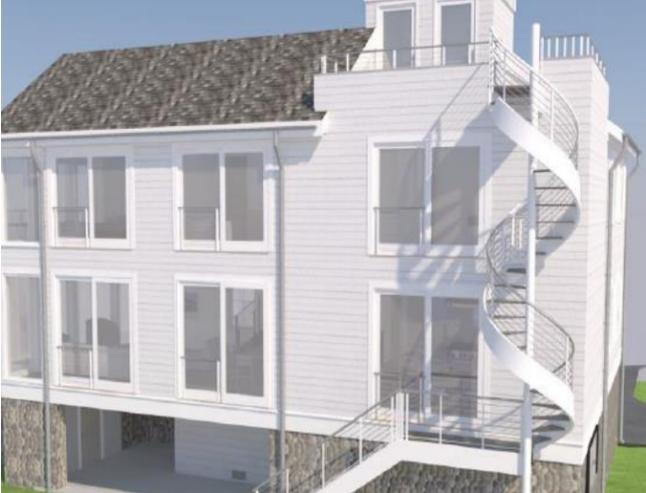
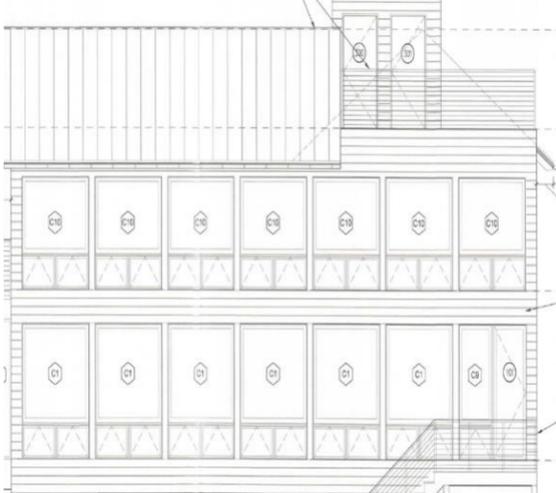
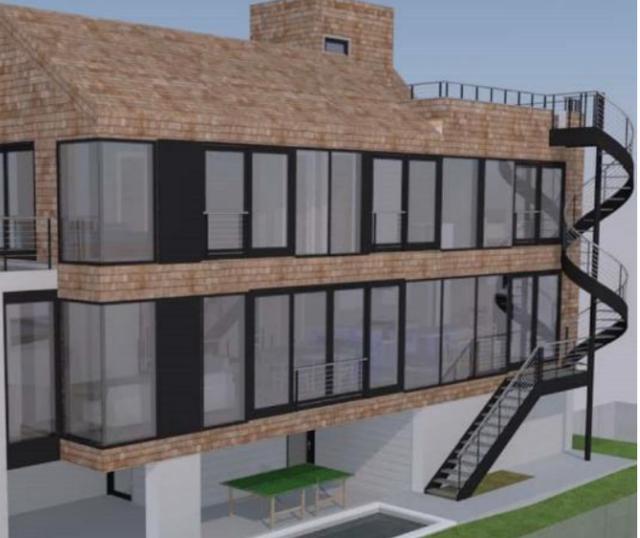
<p><b>Windows</b></p> <p>All windows, type and location, have been installed inconsistent with the ZBA #7627 approval.</p> <p>Plans submitted for the Revoked Zoning Permit #42345 show the same location as constructed on the rear elevation, but throughout the building changes have been made. See other photos.</p>

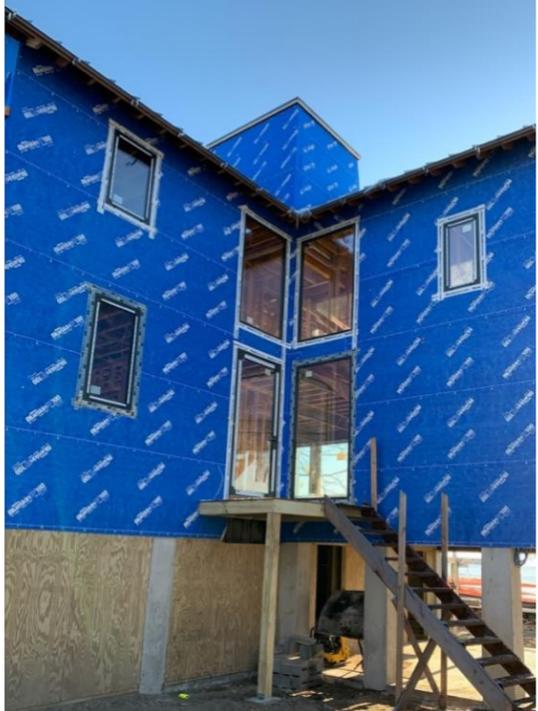
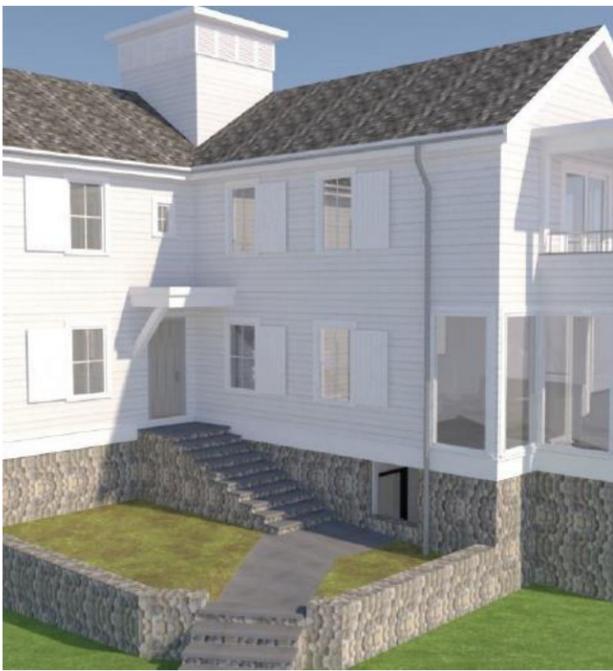
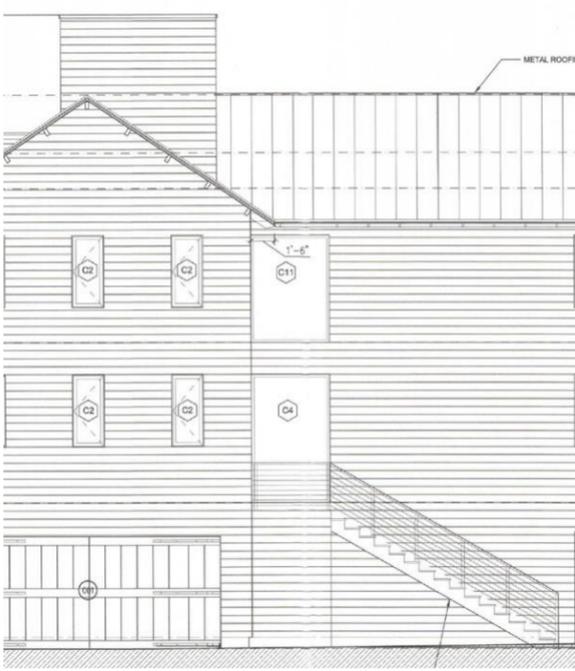
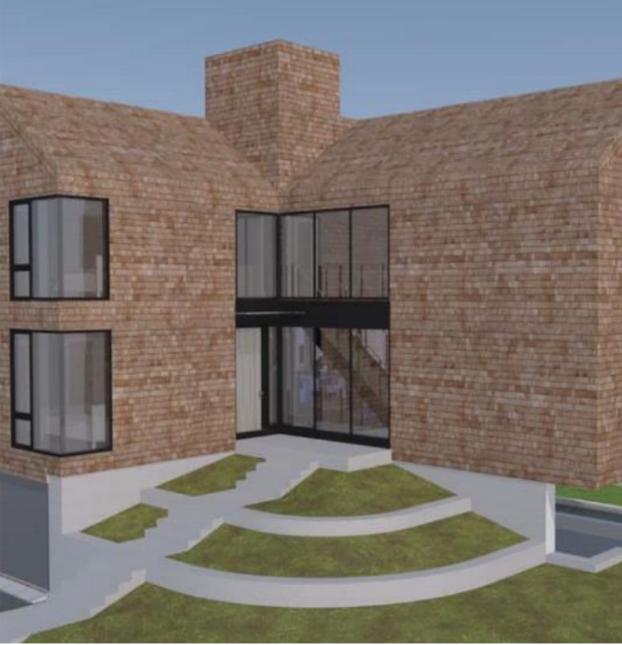
Site Photo 12/20/2019	Approved ZBA #7629 Plans	Plans submitted by applicant for Revoked Zoning Permit # 42345	Denied ZBA #7592 Plans
<p><b>Front Entry</b></p> <p>The front entrance that has been constructed is inconsistent with ZBA #7627 approved plans.</p> <p>Plans submitted for the Revoked Zoning Permit #42345 show a similar configuration as to what is in the field, though it is not clear as the staircase that exists is temporary.</p> <p>Fill and retaining walls were approved in ZBA application #7629. which served to “ground” the building. Currently the building has been constructed on piers.</p>

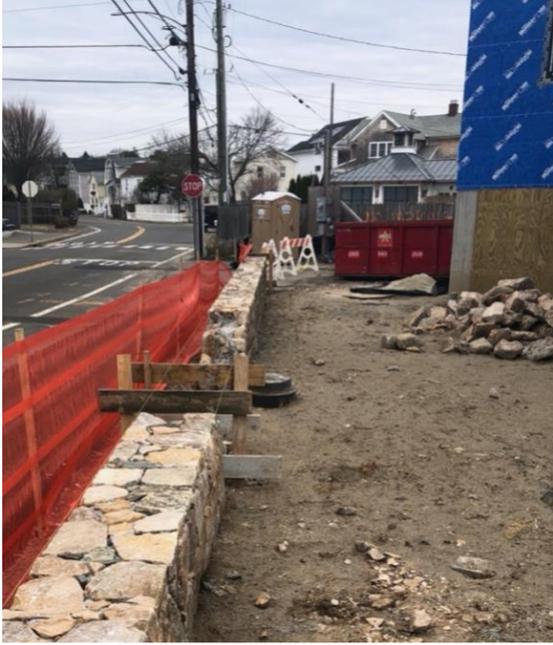
<p style="text-align: center;">*This Photo taken 3/29/2020.</p>

<p><b>Front wall and sidewalk</b></p> <p>The wall was not present on site on 12/19/20 and 12/20/2019 as documented by staff photos.</p> <p>The wall is not present in either the approved ZBA #7629 plan or the Revoked Zoning Permit.</p> <p>A condition of ZBA #7629 approval was that the brick walkway be retained. The walkway is currently asphalt and the width is not equivalent to what was on the ZBA approved plans.</p>

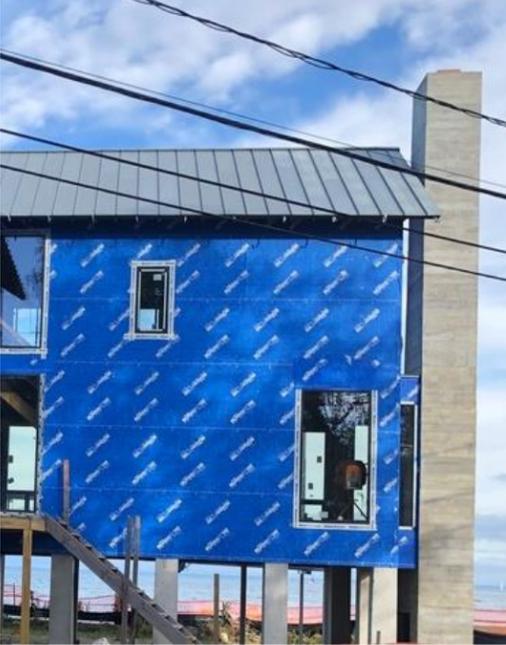
<p style="text-align: center;">*This photo taken 6/17/2020</p>

Site Photo 12/20/2019	Approved ZBA #7629 Plans	Plans submitted by applicant for Revoked Zoning Permit # 42345	Denied ZBA #7592 Plans
<p><b>Building Materials</b></p> <p>The applicant has made significant changes to the materials from the approved ZBA #7629 plans. The approved ZBA plans have a cedar wood roof and painted cedar shingle siding. There is a stone veneer foundation. The windows are divided lites and there are shutters for the windows.</p> <p>The plan the applicant submitted for the Revoked Zoning Permit has horizontal cedar siding, a masonry chimney and metal roofing. The photograph reveals that the location of the windows and detailing are not consistent with either the Revoked Zoning Permit or the ZBA approved plans</p>
